# A Review of Power Outages and Restoration Following the June 2012 Derecho

Infrastructure Security and Energy Restoration  
Office of Electricity Delivery and Energy Reliability  
U.S. Department of Energy

August 2012

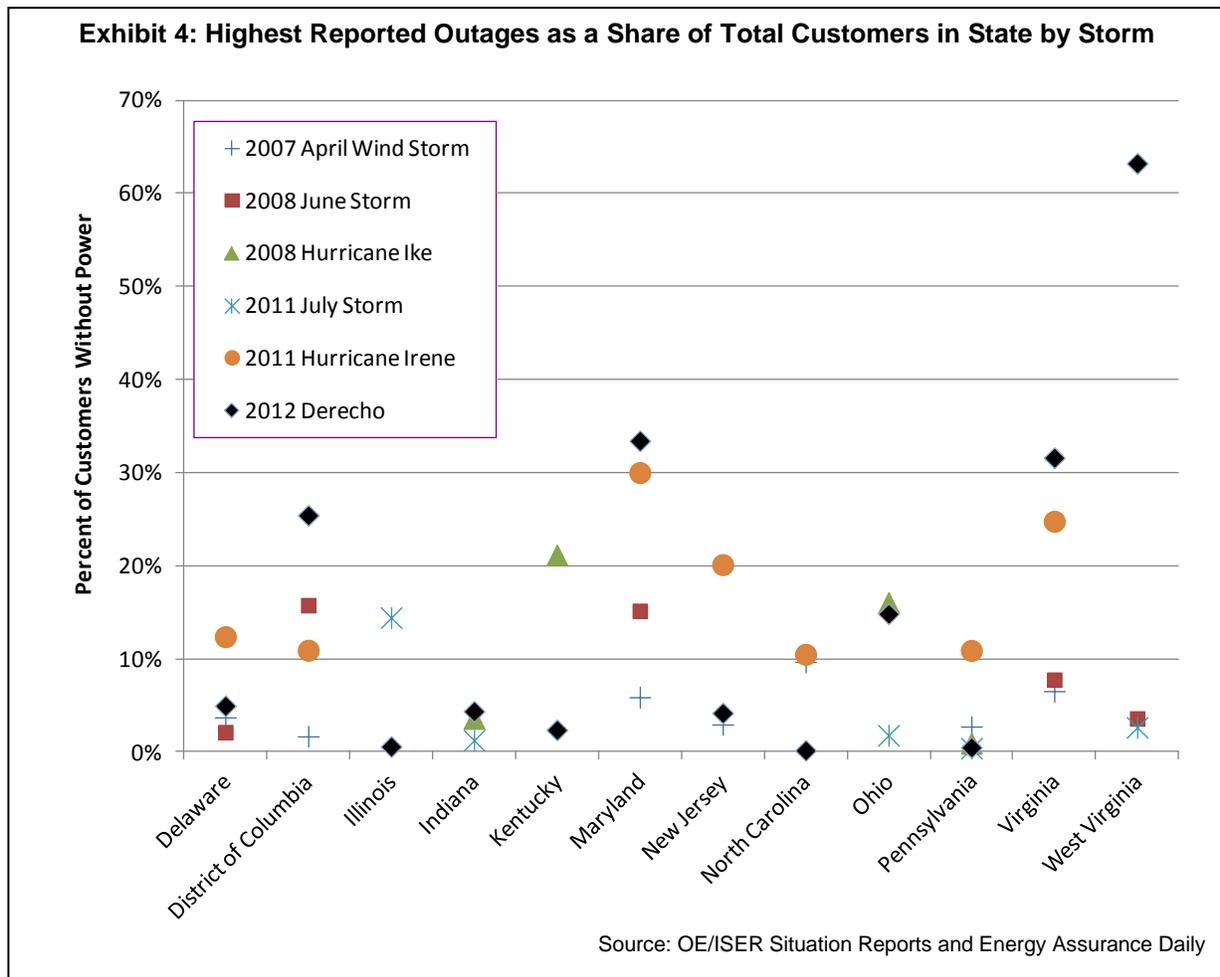
Exhibit 4 presents the highest reported customer power outages by State as a share of total State customers for each storm. This exhibit indicates that of the storms analyzed for this report, the 2012 Derecho was the worst major summer storm to affect utilities in several States over the past five years. For example, West Virginia had 63 percent of electric utility customers without power after the storm, followed by Maryland with 33 percent, Virginia with 32 percent, and the District of Columbia with 25 percent, respectively. By contrast, New Jersey, Pennsylvania, North Carolina, and Delaware were more heavily affected by Hurricane Irene, while Ohio and Kentucky were most severely impacted by Hurricane Ike.

Due to the limited and inconsistent nature of the data reported in Exhibits 8 through 10, conclusive statements comparing damage by storm or utility are not possible. However, the 2012 Derecho caused more customer power outages to five States in the Ohio Valley and Mid-Atlantic regions (see Exhibit 4) than other major storms, suggesting that the Derecho may have caused more damage to electric infrastructure for some utilities in those States. Utilities did not report specific damage information for the April 2007, June 2008, or July 2011 storms. This lack of information may be indicative of the relatively faster restoration times from these storms, which were not as severe as the 2012 Derecho or Hurricanes Irene and Ike.

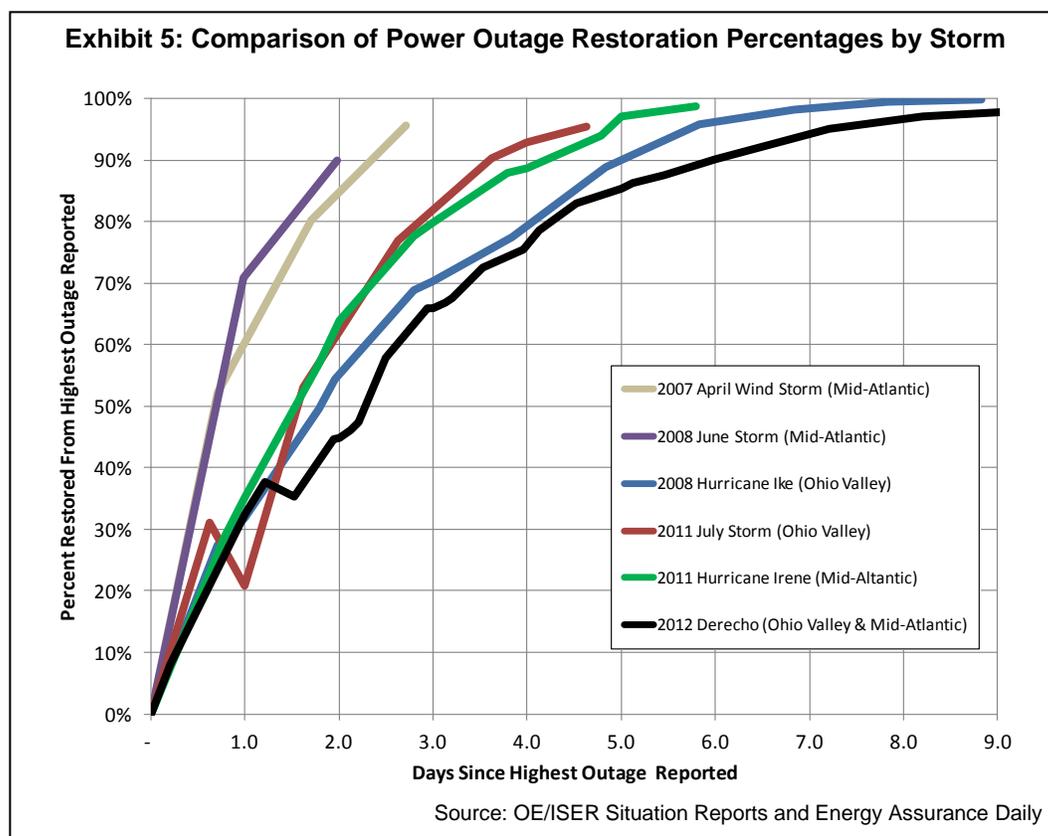
OE/ISER compared power restoration following the 2012 Derecho with restoration efforts following other major spring and summer storms that impacted the Ohio Valley and Mid-Atlantic regions over the past five years. Exhibit 5 plots a time series of power restoration following the 2012 Derecho in terms of the percent of customers restored since the highest number of customers reported without power. For the 2012 Derecho, time zero in the chart corresponds with the highest number of customers reported without power in the morning after the storm, at 9 a.m. EDT June 30, 2012. Power restoration time series for other major spring and summer storms that affected the Ohio Valley and/or Mid-Atlantic regions are also presented in Exhibit 5.

Exhibit 5 indicates that power restoration following the 2012 Derecho took longer than the restoration following other severe spring and summer storms affecting the Ohio Valley and Mid-Atlantic regions. However, over the first day following the highest outage report, power restoration largely kept pace with restoration following other major storms. New storms impacted the region during the second day of restoration, causing additional outages, and setting back restoration. Two days after the highest outage report, utilities had restored power to only 45 percent of affected customers following the 2012 Derecho, whereas utilities had achieved restoration rates of 55 percent or higher following other major storms. Utilities had achieved two-day restoration rates at or approaching 90 percent following major storms in April 2007 and June 2008. Had new storms not affected utilities during the second day of recovery, power restoration following the 2012 Derecho would have largely kept pace with restoration following Hurricane Ike, but would have remained slower than restoration efforts following other storms. The factors that contributed to this result, including the arrival of subsequent storms, are discussed in the next section of this report.

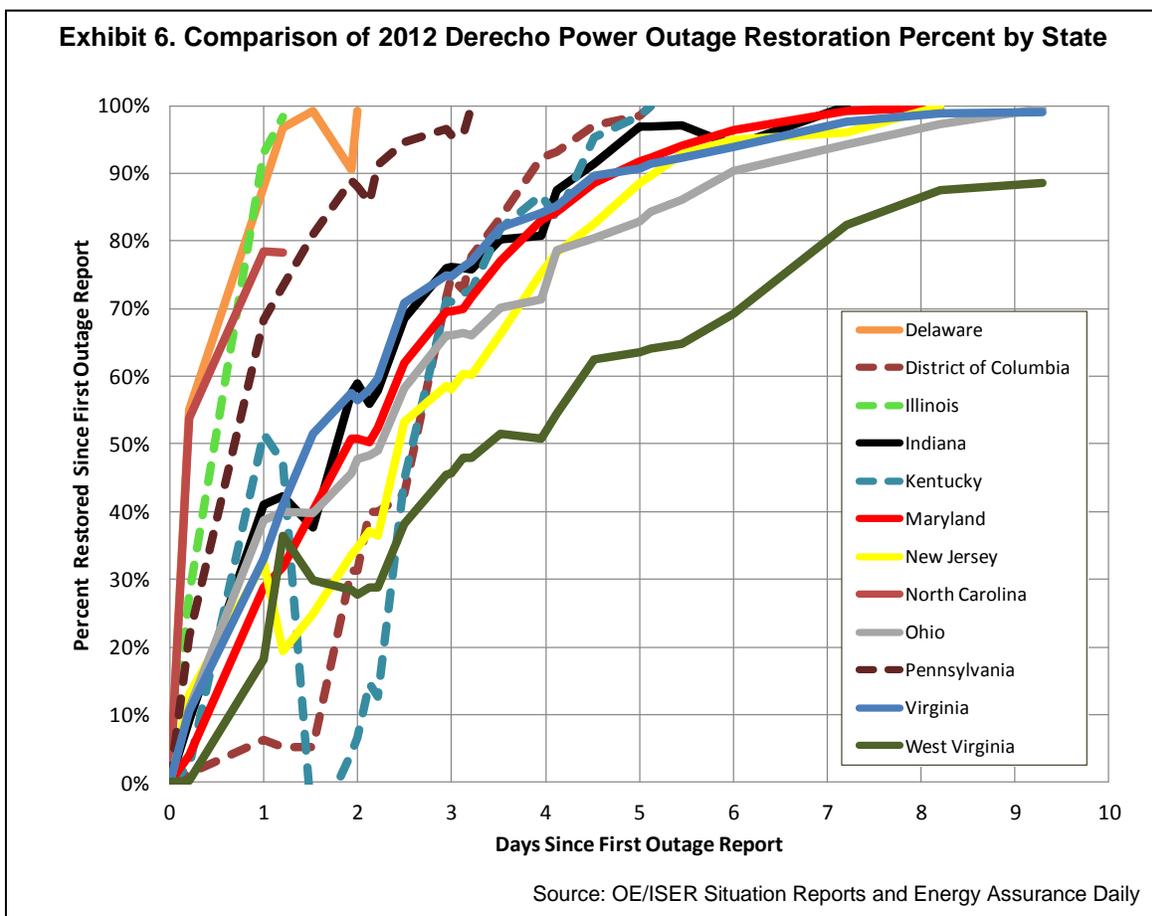
A State-by-State analysis of power outage restoration following the 2012 Derecho is presented in Exhibit 6 below. The exhibit indicates a high variation in restoration rates, particularly over the first two days of restoration. One day after the first outage report, only 6 percent of Washington D.C. customers who lost power had been restored, compared with more than 90 percent restoration for customers who lost power in Illinois. Of the States with the highest absolute number of outages (Maryland, Ohio, Virginia, and West Virginia), restoration in Maryland and Virginia proceeded at a faster rate, with more than 80 percent of customers who lost power in those States restored after four days, compared with restoration rates of roughly 71 percent for Ohio and 51 percent in West Virginia, respectively. It should be noted that restoration can vary by State for a number of reasons. Topography, population density, damage levels, tree removal and subsequent storms can all affect the rate of power restoration. The Ohio Valley region in particular experienced additional storms during the restoration period, adding new outages and slowing the pace of restoration in those States.

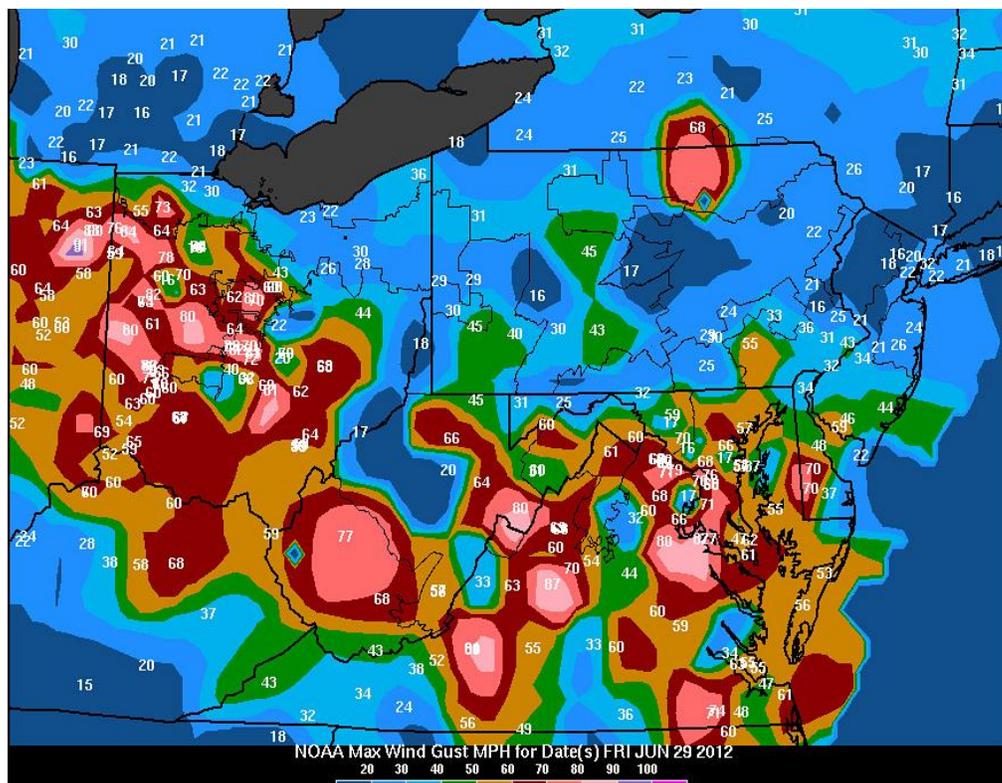
**Exhibit 7: Maximum Wind Gusts from 2012 Derecho**

The 2012 Derecho was a particularly severe wind event that covered a large area across regions. According to the National Weather Service, the area impacted by the 2012 Derecho experienced wind speeds averaging 60 miles per hour with wind gusts in the range of 80 to 100 miles per hour over a 10 hour period.<sup>7</sup> By comparison, a category 1 hurricane is characterized by sustained wind speeds in the range of 74 to 95 miles per hour, while a tropical storm is characterized by wind speeds ranging from 39 to 73 miles per hour.<sup>8</sup> However, hurricanes and tropical storms typically deliver the most severe wind speeds to coastal areas, and lose considerable strength as they move inland. The 2012 Derecho, by contrast, delivered direct, straight-line winds, to a wide swath of the Ohio Valley and Mid-Atlantic. Exhibit 7 below, from NOAA, presents a map showing maximum wind gusts in the area impacted by the Derecho on June 29, 2012.

Exhibit 7 shows the greatest bandwidth of wind intensity covering a wide area of rural, heavily tree-covered areas. The wind damage to trees was very extensive over the entire storm area. The ability to remove trees quickly was limited due to the number of trees (many of massive size) which were felled onto power infrastructure located in many cases on consumer- and county-owned property. Power repair crews often required tree removal crews to clear the site first before power repairs could be started.

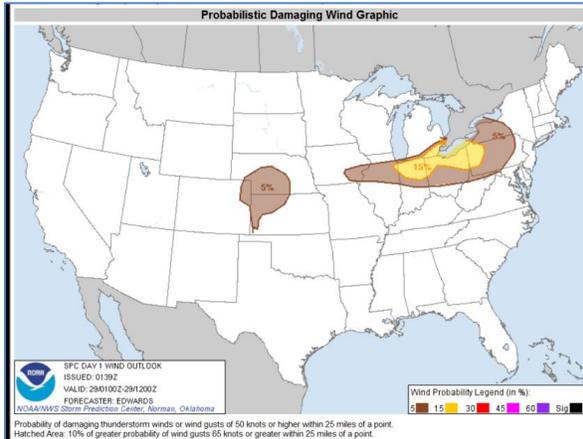
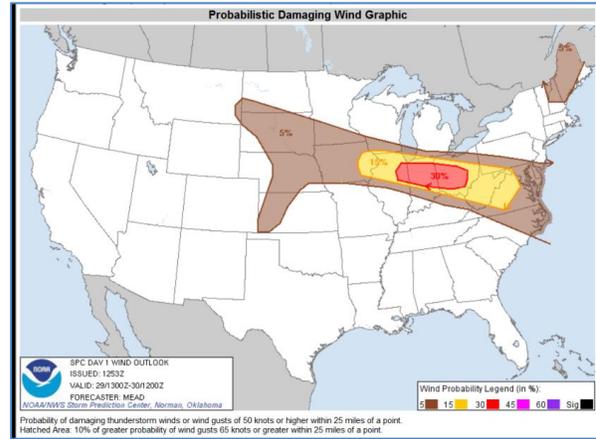
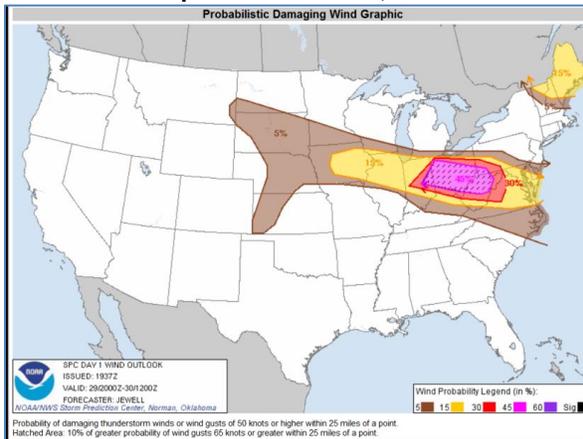
## Exhibit 11: NOAA Convective Outlook Comparison, June 28-29, 2012

Analysis of forecasting prior to the 2012 Derecho indicates that there was minimal notice to any of the utilities in impacted areas that a storm of the 2012 Derecho's magnitude was likely. Exhibit 11 below shows forecast wind maps from the NOAA. At 9 p.m. EDT on June 28—the day before the storm—NOAA forecasted low to moderate winds across the northern portion of Illinois and Indiana, the southern portion of Michigan, most of Ohio, and large parts of western New York and Pennsylvania. At 11 a.m. EDT, June 29—just three hours before the storm began in Illinois—NOAA significantly increased its wind forecast for the region, expanding its wind probability zone across much of the northern Midwest and Mid-Atlantic. At 6 p.m. EDT, after the storm had already begun impacting Illinois, Indiana, and Ohio, NOAA again expanded the area it expected to receive damaging thunderstorm winds and began forecasting severe winds at or above 65 knots for parts of Indiana, Ohio, and West Virginia.

Exhibit 11 indicates that over the 24 hours preceding the 2012 Derecho, forecasts changed from predicting a storm with relatively moderate wind speeds and a limited geographic scope to predicting a devastating storm with damaging wind speeds covering a much broader area of the country. This afforded little time for utilities to conduct resource planning and mobilization, particularly for utilities serving parts of southern Ohio, West Virginia, Maryland, and Virginia, which were not in the area of expected storm activity predicted by NOAA's 9 p.m. June 28 forecast.

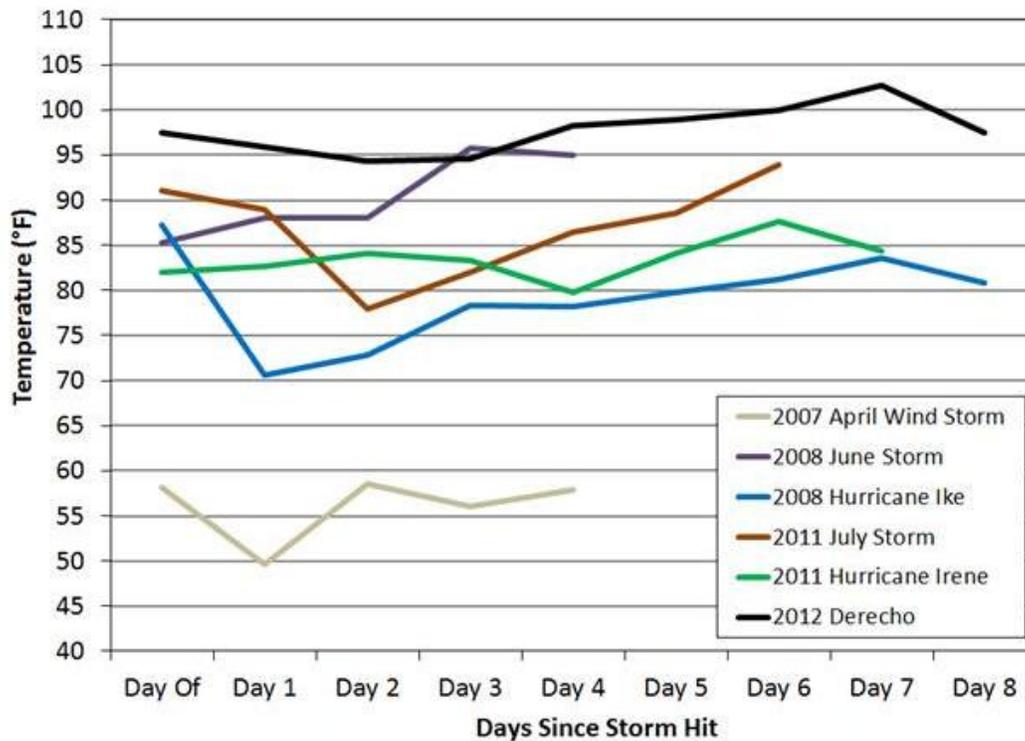
Exhibit 12: Average Daily Temperature Highs during the Restoration Period by Storm

Extreme temperatures that followed the 2012 Derecho may have complicated restoration efforts for many utilities. Extreme heat can pose a safety risk to utility crews and lower restoration efficiency. Several utilities reported taking extra measures, such as distributing water and energy drinks, and supplying ice to utility crews to combat the heat.<sup>14</sup> AEP Ohio reported that five of its utility workers were treated for heat-related injuries as they worked to restore power amid 100°F temperatures between July 2 and July 6.<sup>15</sup> Exhibit 12 compares the average high temperatures from the 2012 Derecho with other recent spring and summer storms discussed above.<sup>16</sup> It shows the temperatures the day of the storm and the days following it (the restoration period). Average post-storm temperatures in the 2012 Derecho impact area consistently stayed above 94°F and far exceeded the temperatures following other storms.
